TRANS ATLANTIC DIESELS, Inc.

MARINE ENGINE OVERHEATING

SOME CAUSES & SUGGESTIED REMEDIES

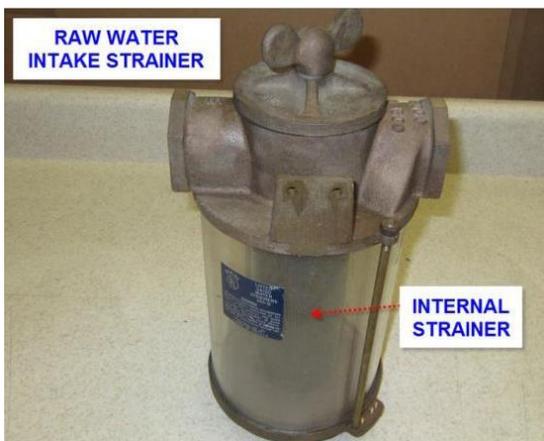
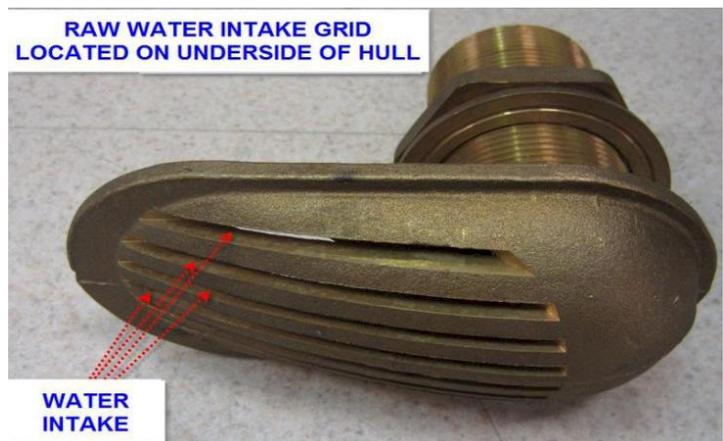
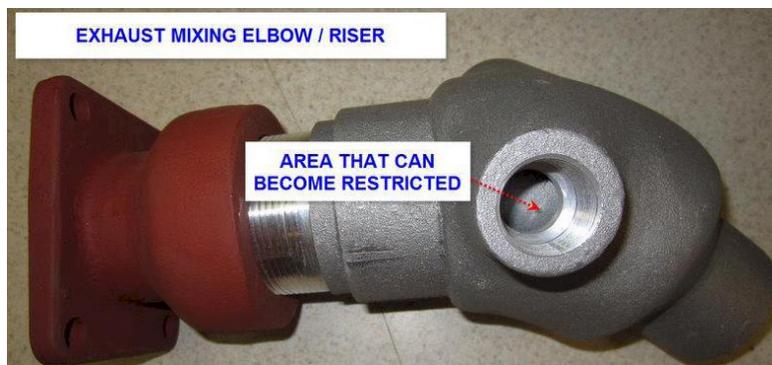
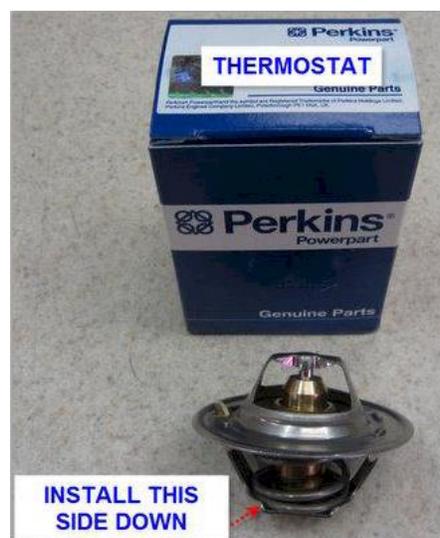
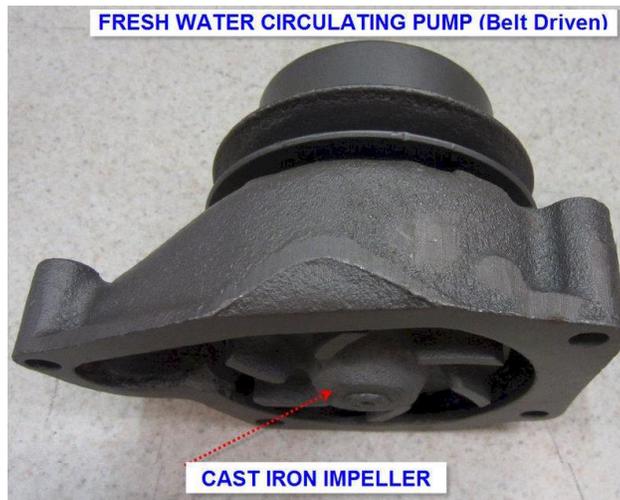
The sample images shown below are from a Perkins 4.108. They are intended as a guide to familiarize you with some items associated with engine cooling that have been referenced in this document. Your particular items will vary by engine and vessel.

To familiarize you with the appearance of some of these pumps and other cooling components, there are some sample pictures at the bottom of the page.
